CONSERVATION NEEDS ASSESSMENT REPORT FOR  
**THE PARTHENON AND HISTORIC CONCRETE STRUCTURES AT CENTENNIAL PARK**

PREPARED FOR:  
METROPOLITAN HISTORICAL COMMISSION OF NASHVILLE  
AND  
CENTENNIAL PARK CONSERVANCY

BY  
CULTURAL HERITAGE CONSERVATION LLC  
&  
SILMAN

30 SEPTEMBER 2021

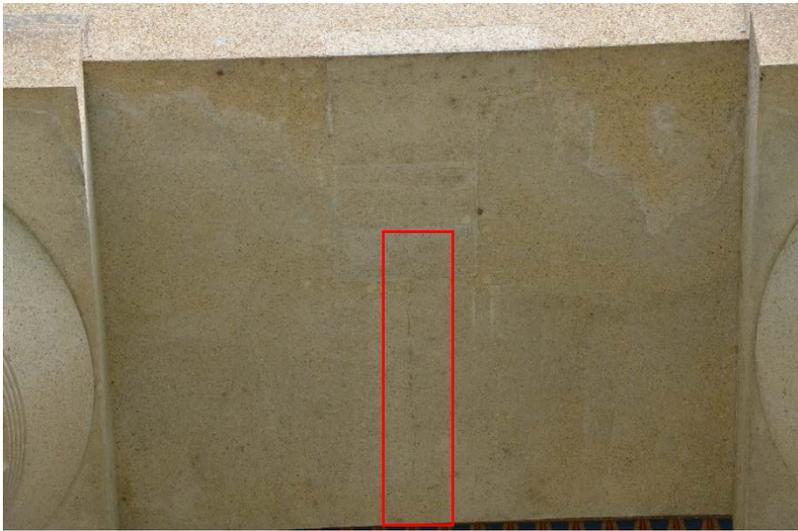
Figure 13: Underside of architrave on south elevation with crack through part of the patch and into original concrete.

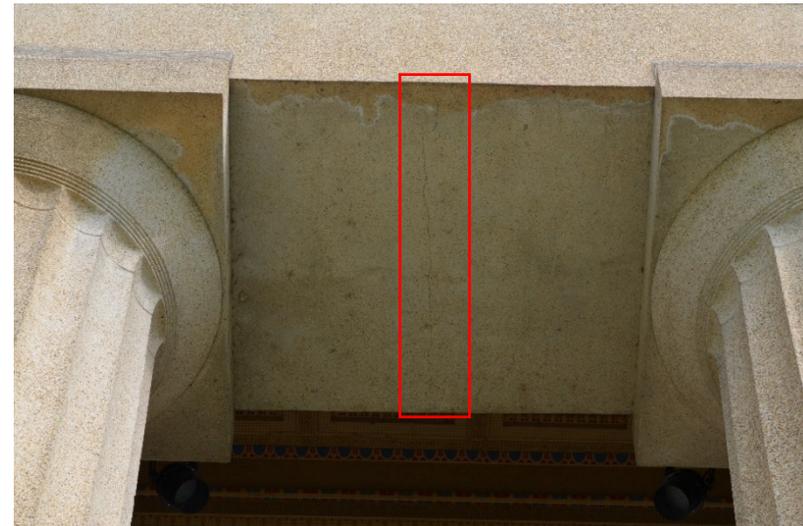
Figure 14: Underside of architrave on south elevation with crack in the middle.

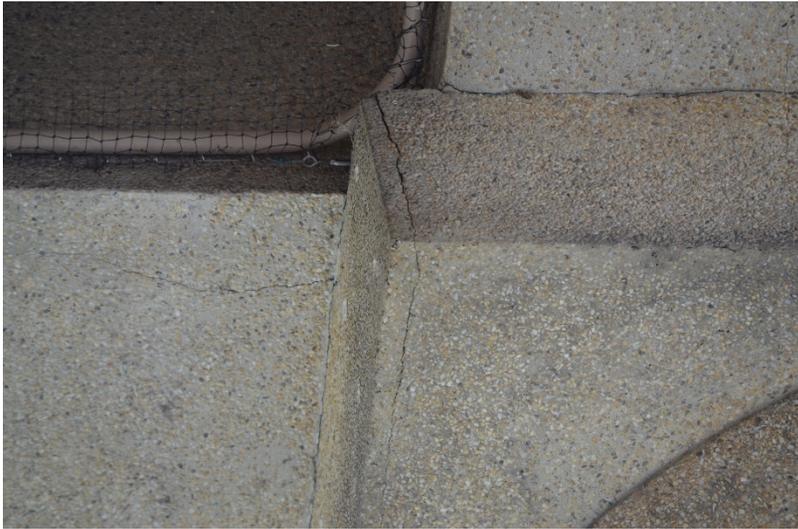
Figure 15: Northeast corner of southwest abacus showing potential spall.

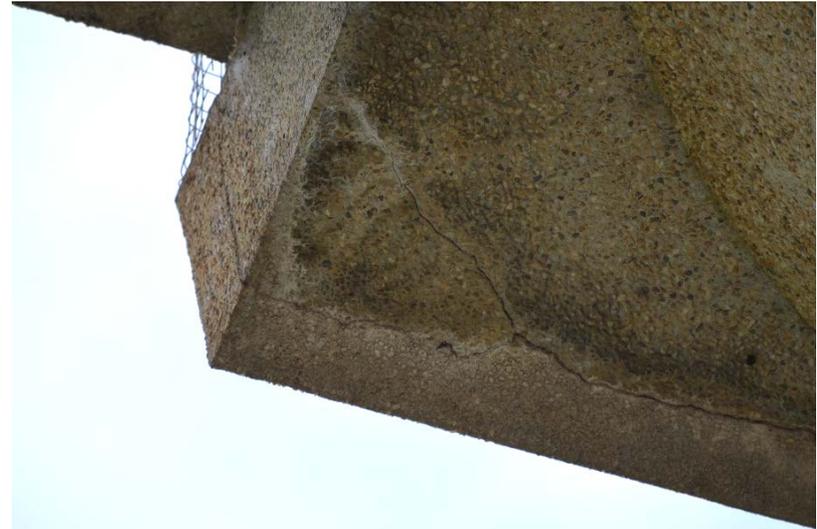
Figure 17: West column abacus showing cracking.

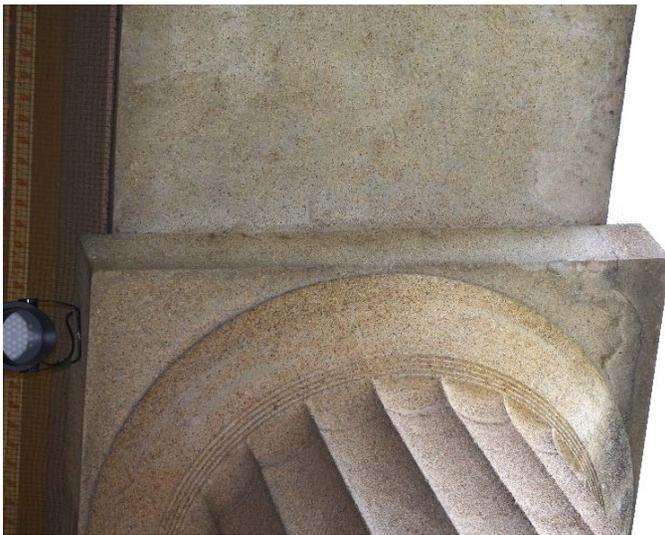
Figure 16: West column abacus showing cracking.

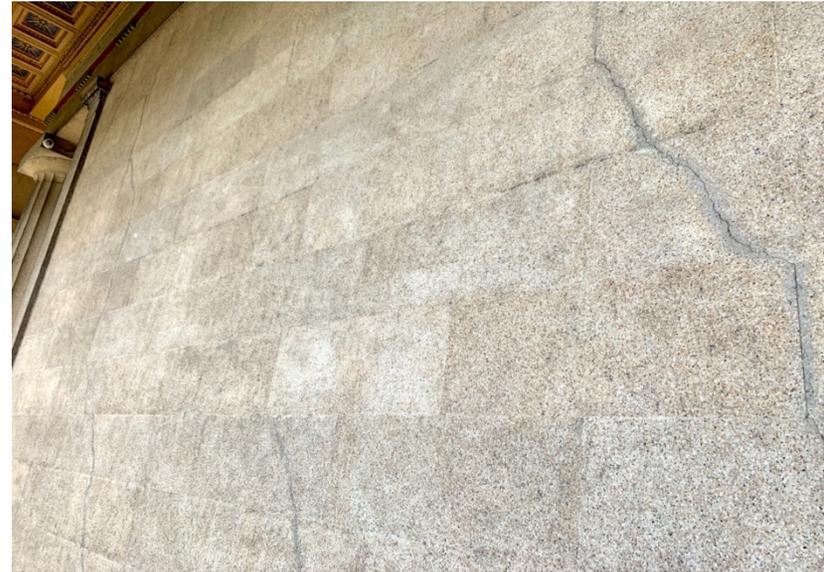
Figure 20: Several cracks in the north wall at east end.

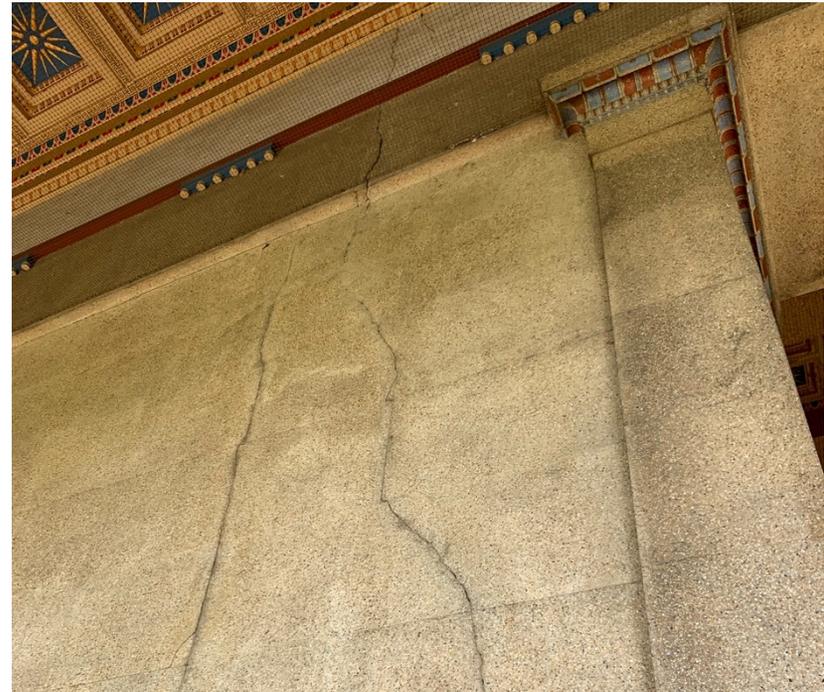
Figure 21: Large cracks on the south wall east end.

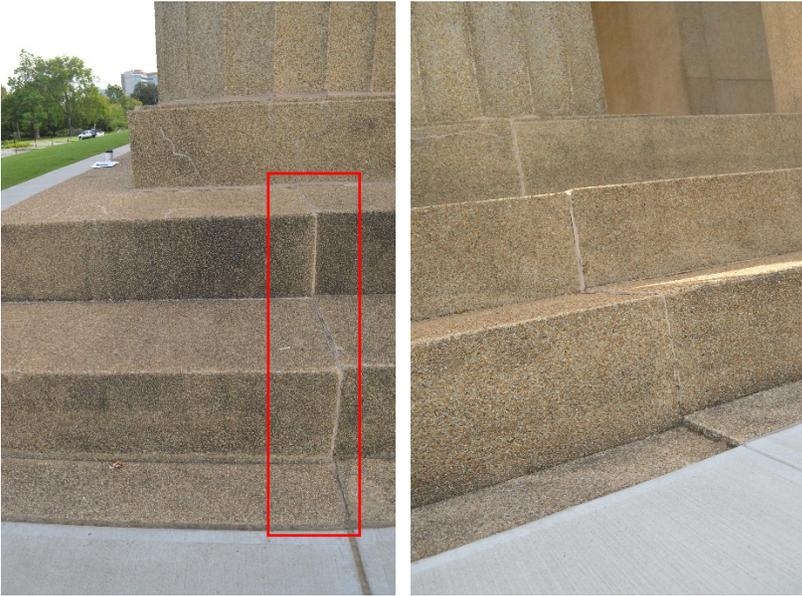
Figure 24: Northwest and northeast corner step misalignment.

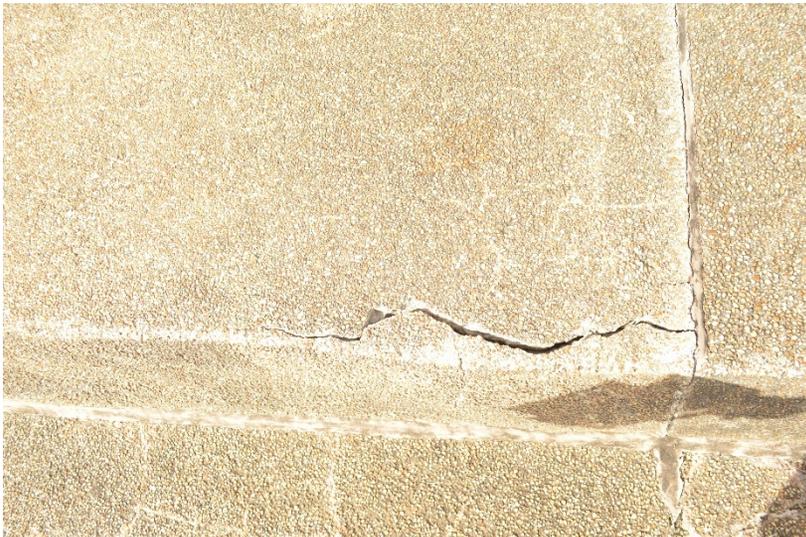
Figure 25: Incipient spall at east elevation, north end.

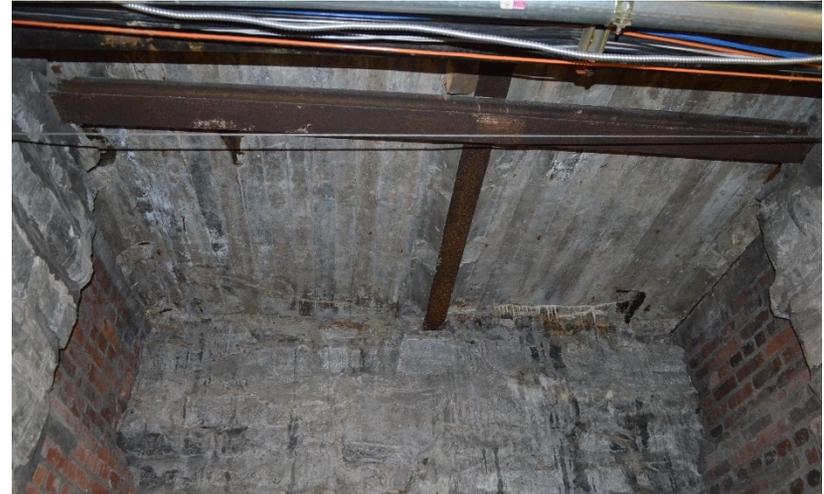
Figure 26: North wall of basement toward the east end showing through cracks and stalactites.

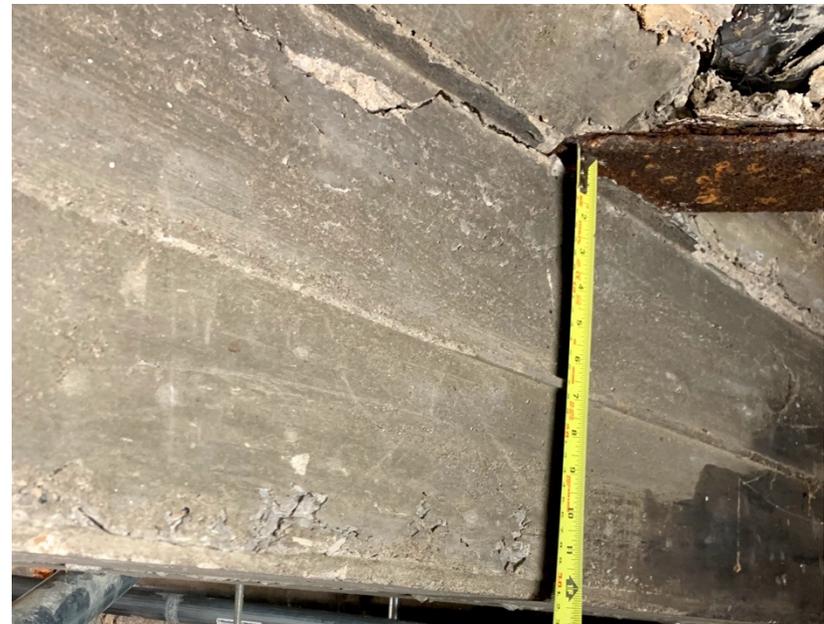
Figure 27: Concrete slab and beam intersected by steel beam.

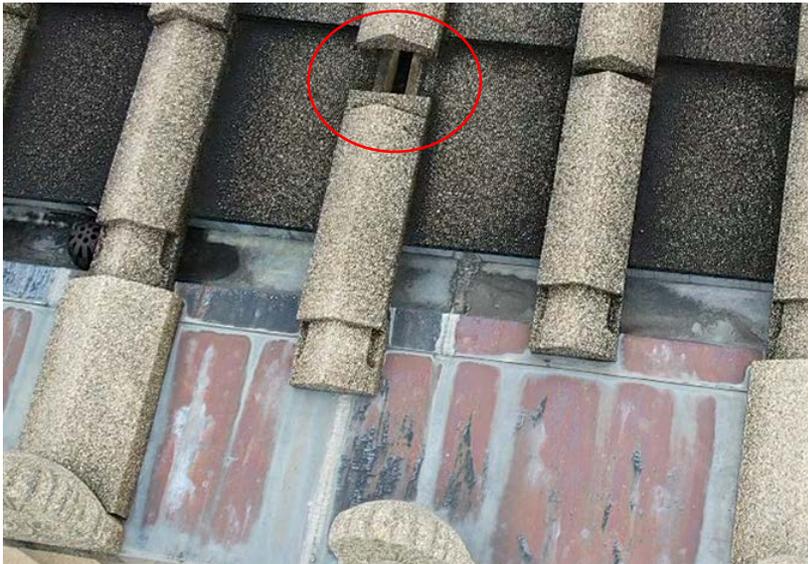
Figure 28: South side of roof has misaligned tile.

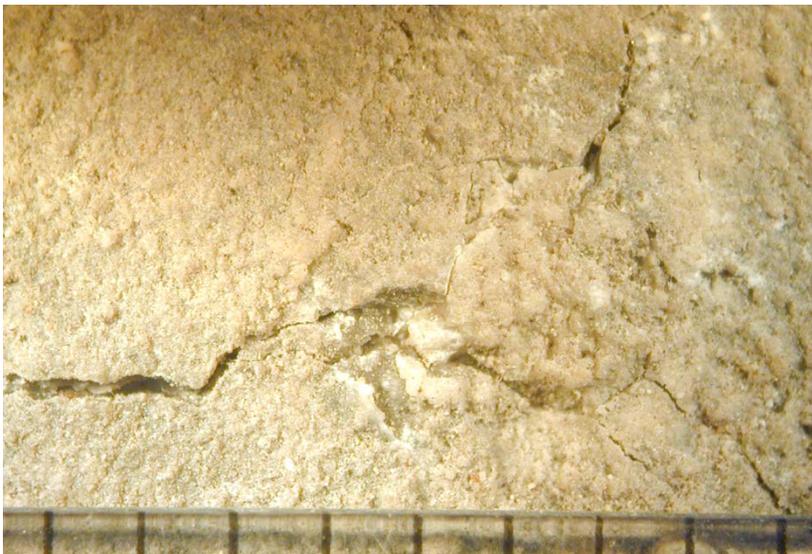
Figure 40: Map cracking of surface with mm scale.

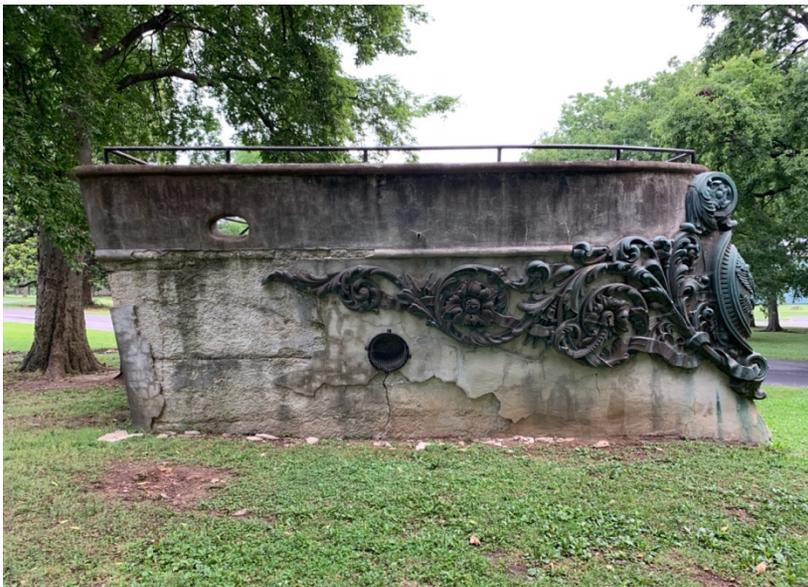
Figure 43: South side depicting loss of the majority of the parging; large cracks, the horizontal one is a cold joint between concrete pours during construction but there is debris and concrete fragments within it, network cracking is apparent on the parapet, and there is loss of concrete on the bullnose detail.

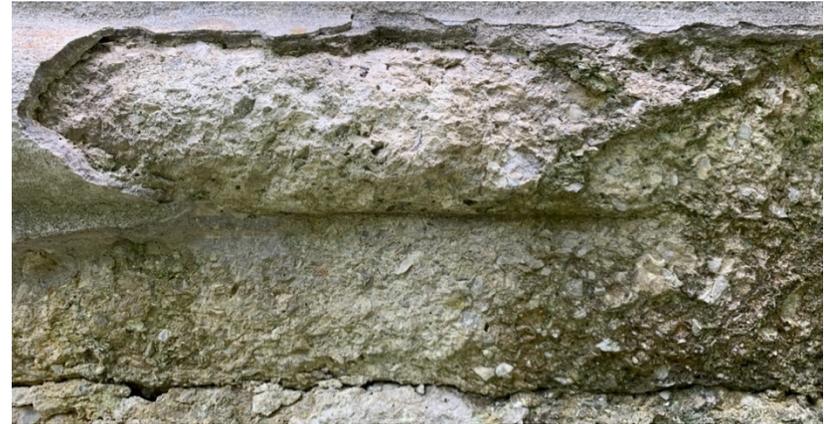
Figure 44: Detail of parging loss, disaggregated concrete, missing concrete, and cracks.

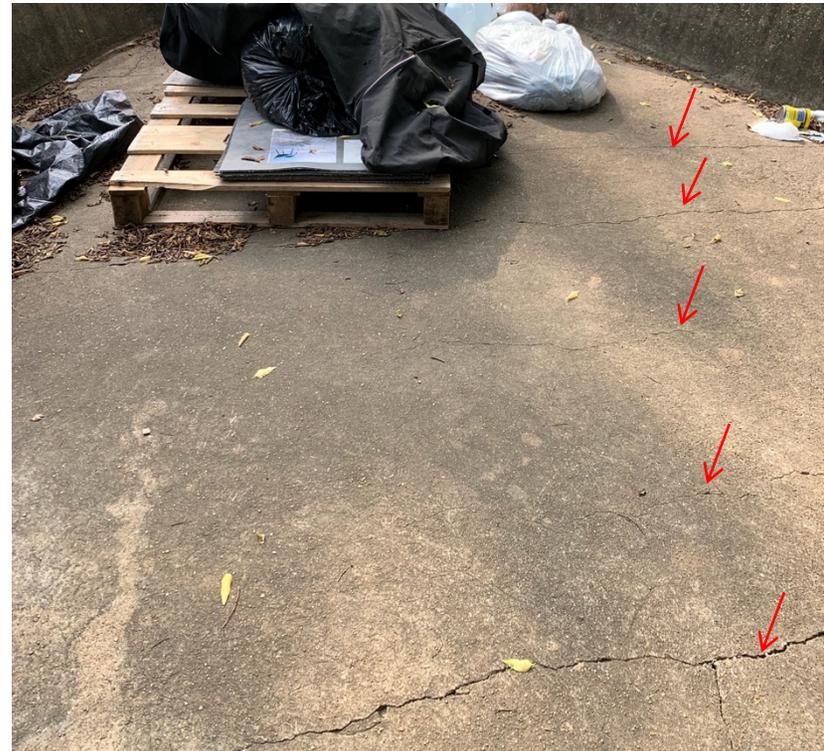
Figure 45: Roof of Gunboat. Note horizontal cracking indicated by red arrows which is likely lined up with and due to corroded rebar within the roof slab (see image below). Due to the potential structural instability of the roof slab the Gunboat should not be accessible to the public.

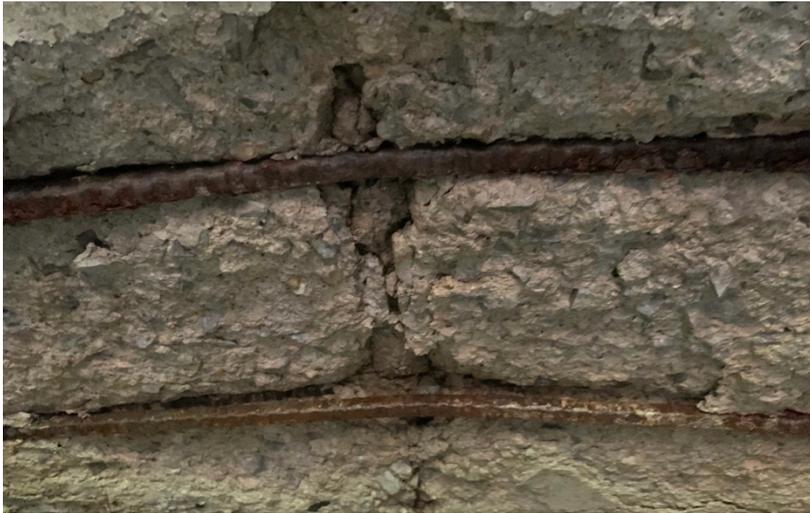
Figure 46: Exposed rebar at the underside of the roof slab. Note deteriorated concrete above it.

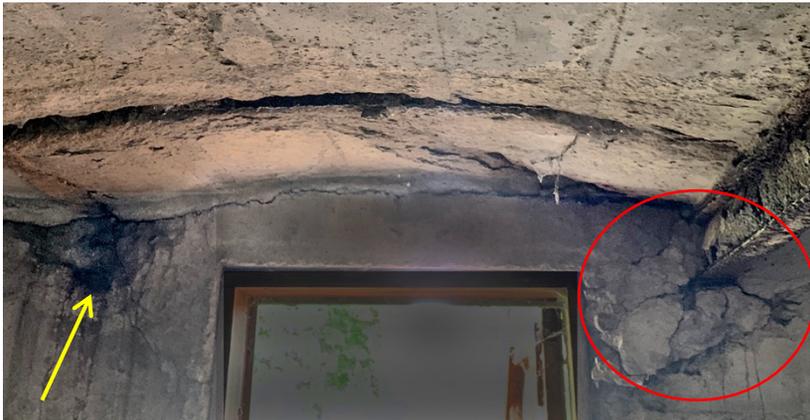
Figure 47: Inside Gunboat looking out. Note the right steel beam has corroded so extensively it has fractured and spalled the concrete around it (red circle). At the left side the beam has fallen from its concrete pocket (yellow arrow). It is not known whether the beams were to support the formwork for construction or serve as structural support to the roof slab which is why the monument should be fenced off.

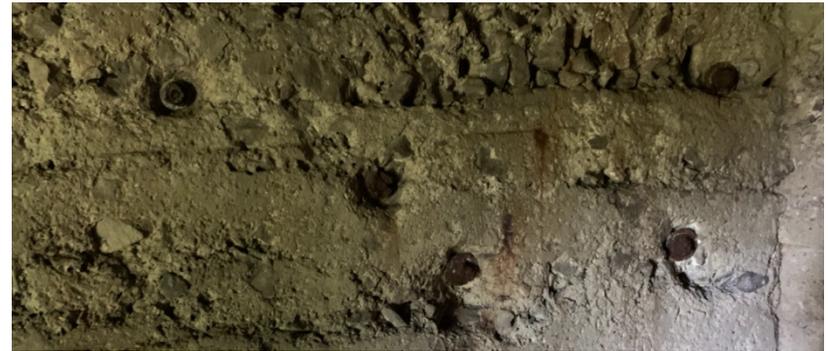
Figure 49: Steel bolts viewed from the interior that support the figurehead are corroding and should be replaced with stainless steel when the figurehead is reinstalled.

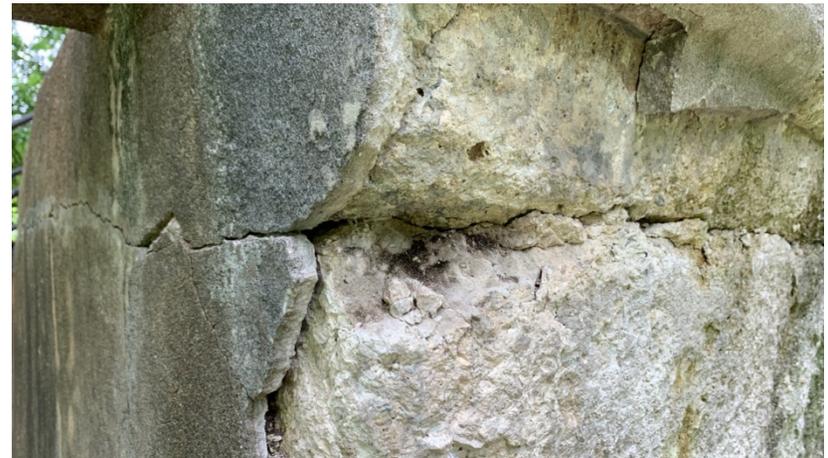
Figure 50: Exterior view looking north from the southwest corner showing the crack in the structural concrete that wraps around to the west in the parging – it is likely a cold joint.

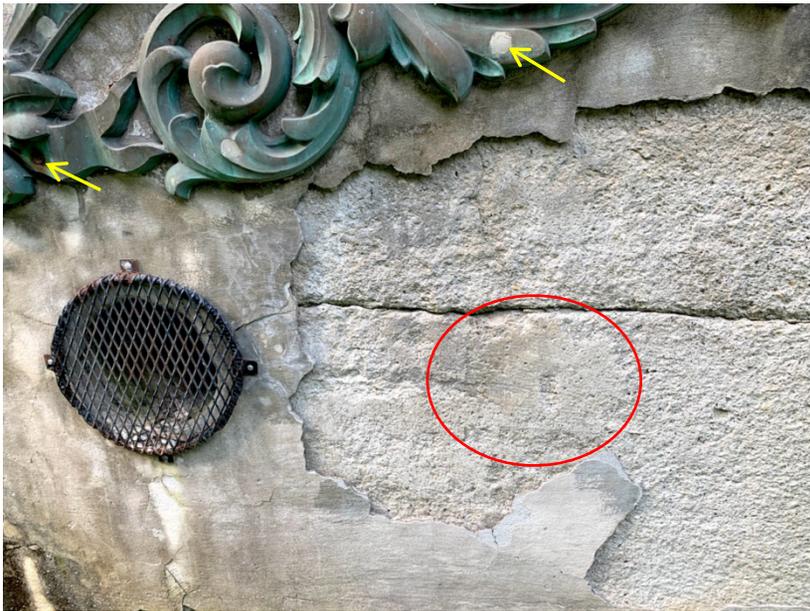
Figure 51: North elevation detail; similar to the preceding image, the crack is likely a cold joint that should receive grout; the red outline (detail below) indicates a surface possibly indicating the original appearance of the concrete or the surface of the concrete prior to an original parge that is not known if it is extant anywhere on the folly. The left yellow arrow shows a rusted steel anchor head in the bronze and the right yellow arrow shows one that has been covered by cementitious material.

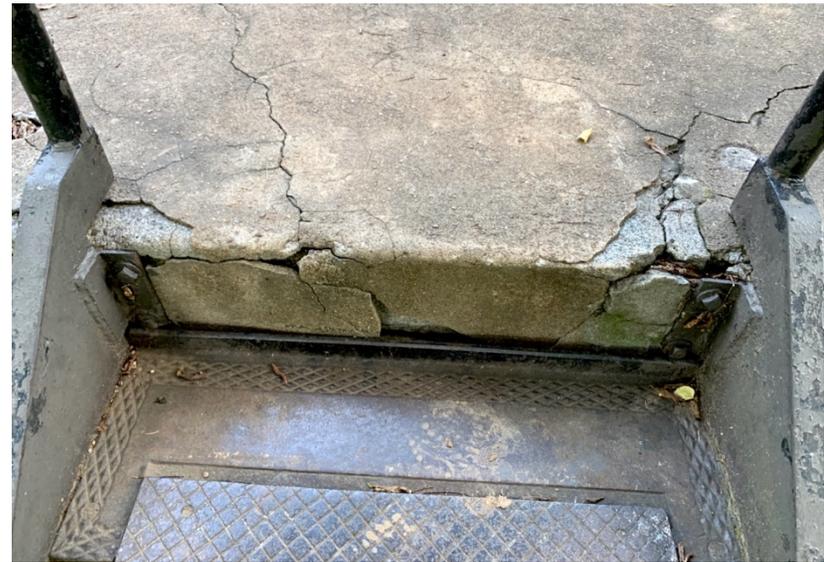
Figure 53: Top of stairs are anchored into the roof slab possibly corroding and causing cracking and spalls. The top layer of concrete is a newer parge but the layer below it may be original suggested by aggregate appearance. Stairs must be removed and concrete repaired and stairs either eliminated or cleaned, restored and reinstalled.

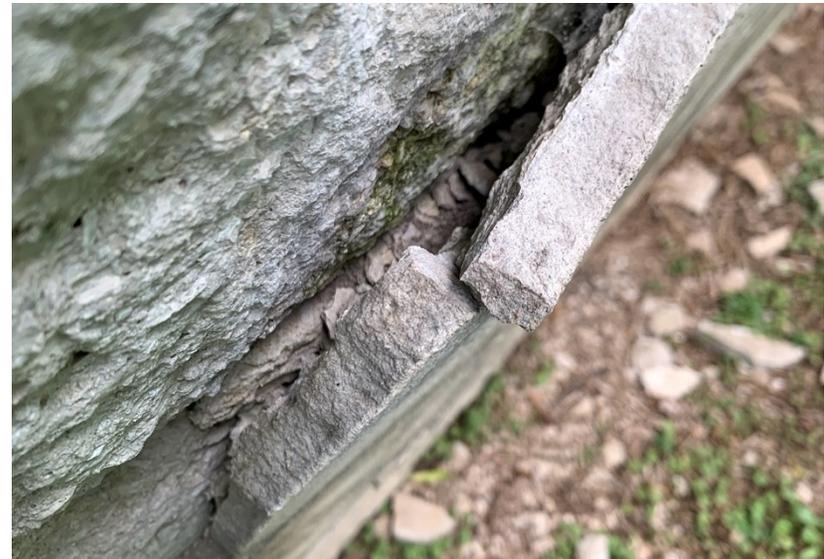
Figure 54: Detail of delamination parging – debris gets in the cracks and separations and pushes the parge coat out of plane making preservation of parging difficult.

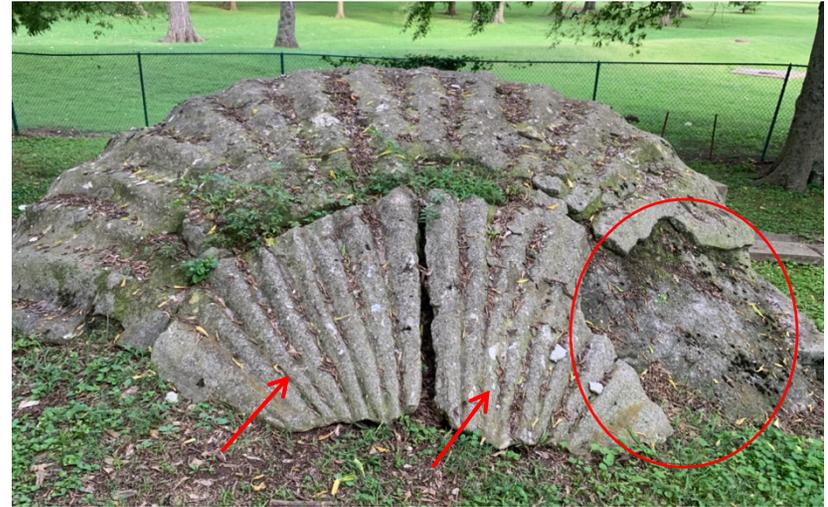
Figure 61: View to south: The clamshell has a scalloped form like the underside, but portions of the scalloping are missing (red outline). The bottom third of the scalloping may have been two separate concrete pours as seen in historic photos depicting what is likely a cold joint. These panels are displaced and have lost fragments (red arrows).

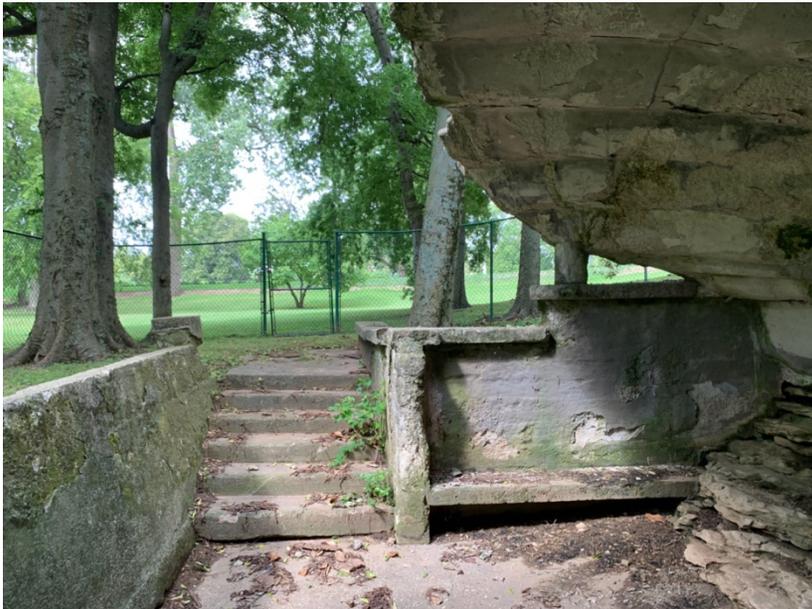
Figure 60: This is a view of the interior space looking west. Stairs lead down to the spring and a bench was built into the side retaining wall. Several attempts at coating the concrete have been made but are incompatible to the historic substrate and are failing themselves.

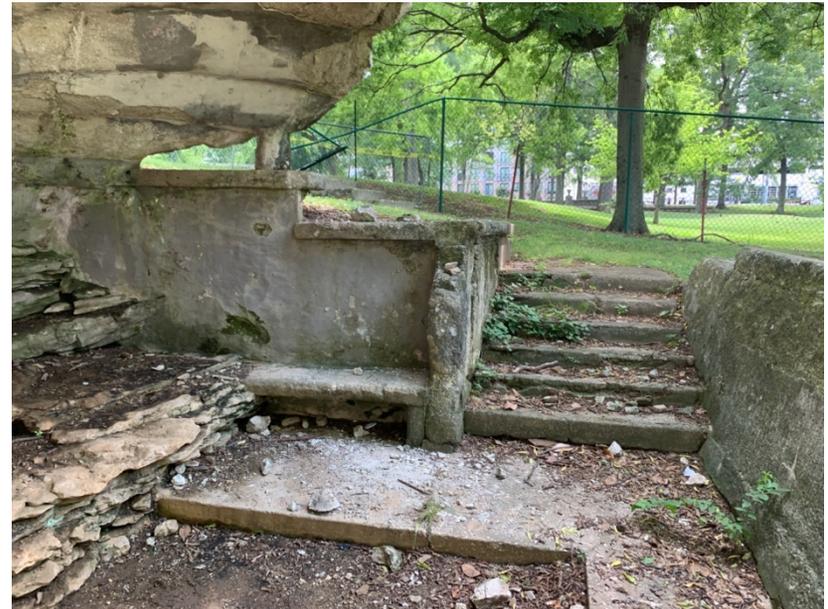
Figure 62: This is a view of the interior space looking east. Stairs lead down to the spring and a bench was built into the side retaining wall. There is a lot of debris within the folly much of which is pieces of concrete fallen from the cantilevered shell.

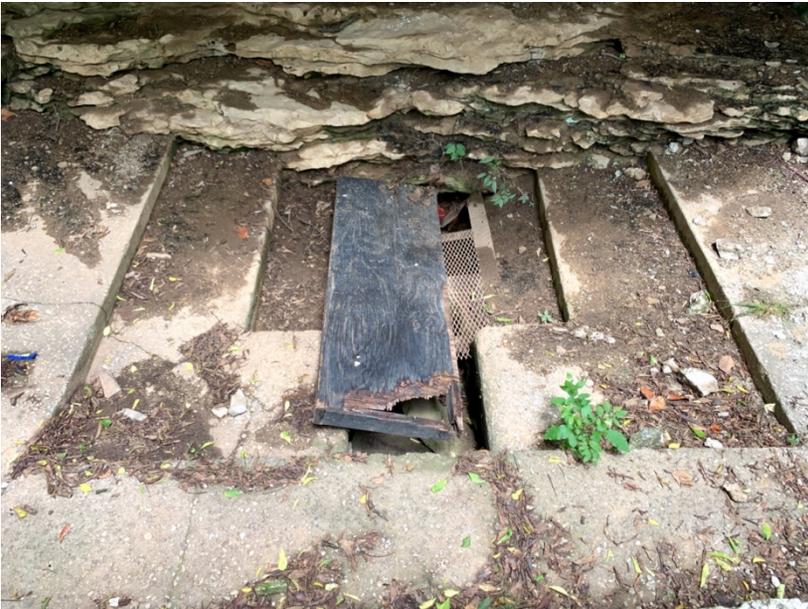
Figure 64: Base of Shell Spring. The spring flows under the grate and plywood box. Removal of debris around the entire slab is recommended for better assessment of the concrete.

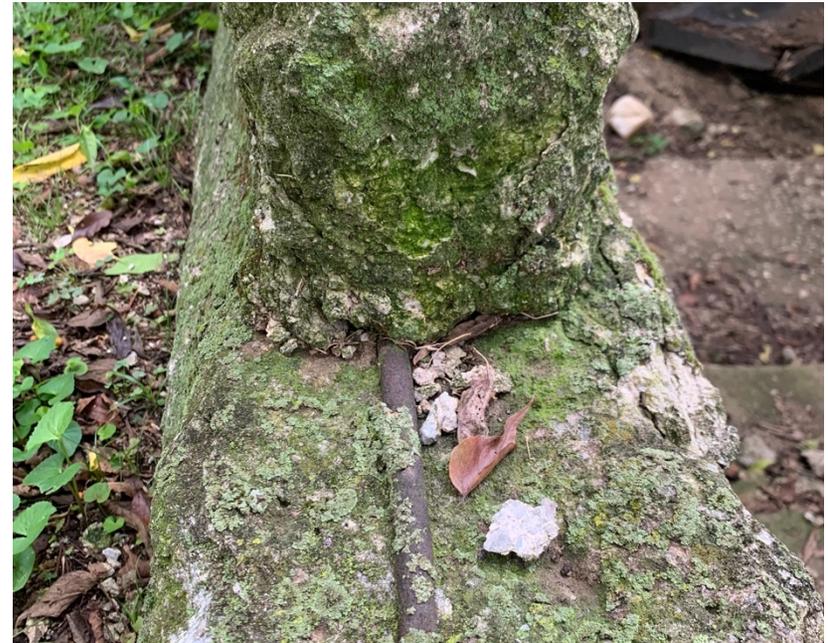
Figure 66: Example of the smooth round steel reinforcement – exposed at the front retaining wall where a large piece of the top of the wall is missing.

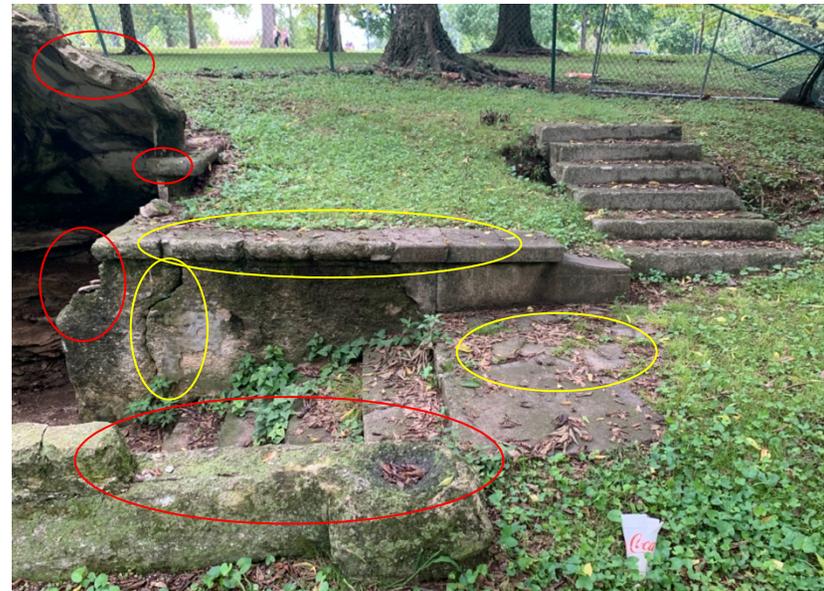
Figure 73: Shell Spring east end; red is lacunae and yellow is cracking.

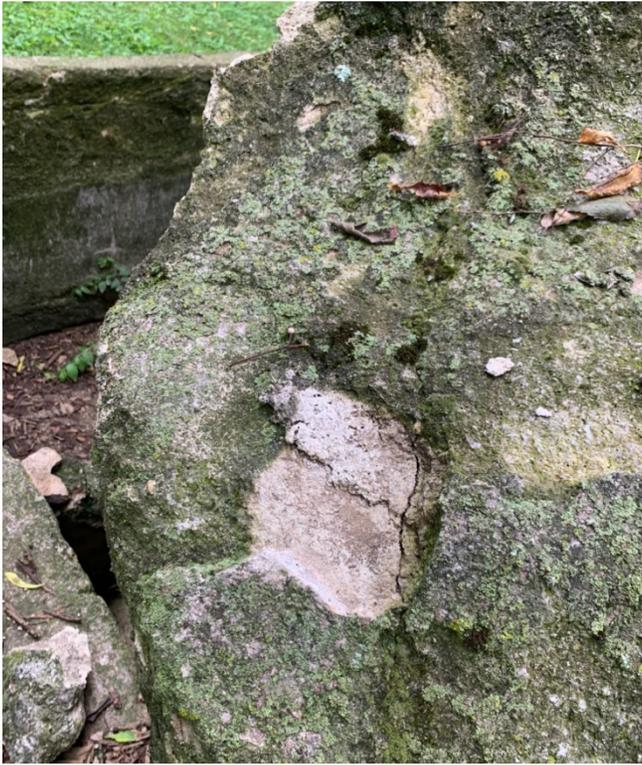
Figure 74: A fragment of concrete from the top of the shell near the front edge was removed and a crack observed under it; this crack may run most of the length of the front edge of the shell as it was also observed on the underside; significant loss is imminent and must be addressed immediately. The more original material extant at the time of intervention the more beneficial for its preservation and/or using it to recreate the front edge with a new casting to complete the form. This image also depicts the thick biogrowth that conceals the concrete from proper assessment.

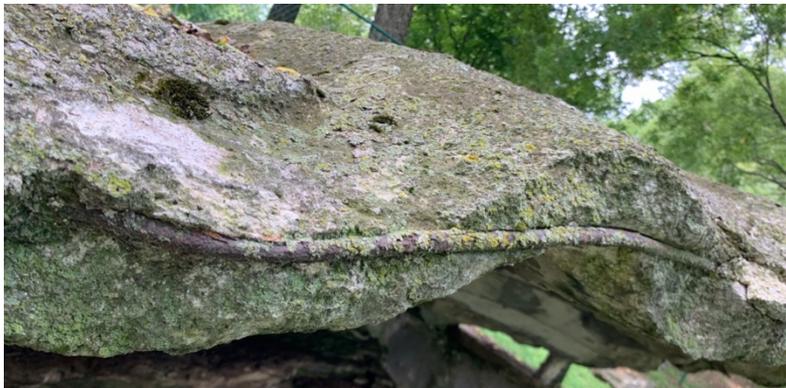
Figure 75: Exposed steel reinforcement at front edge of clamshell.

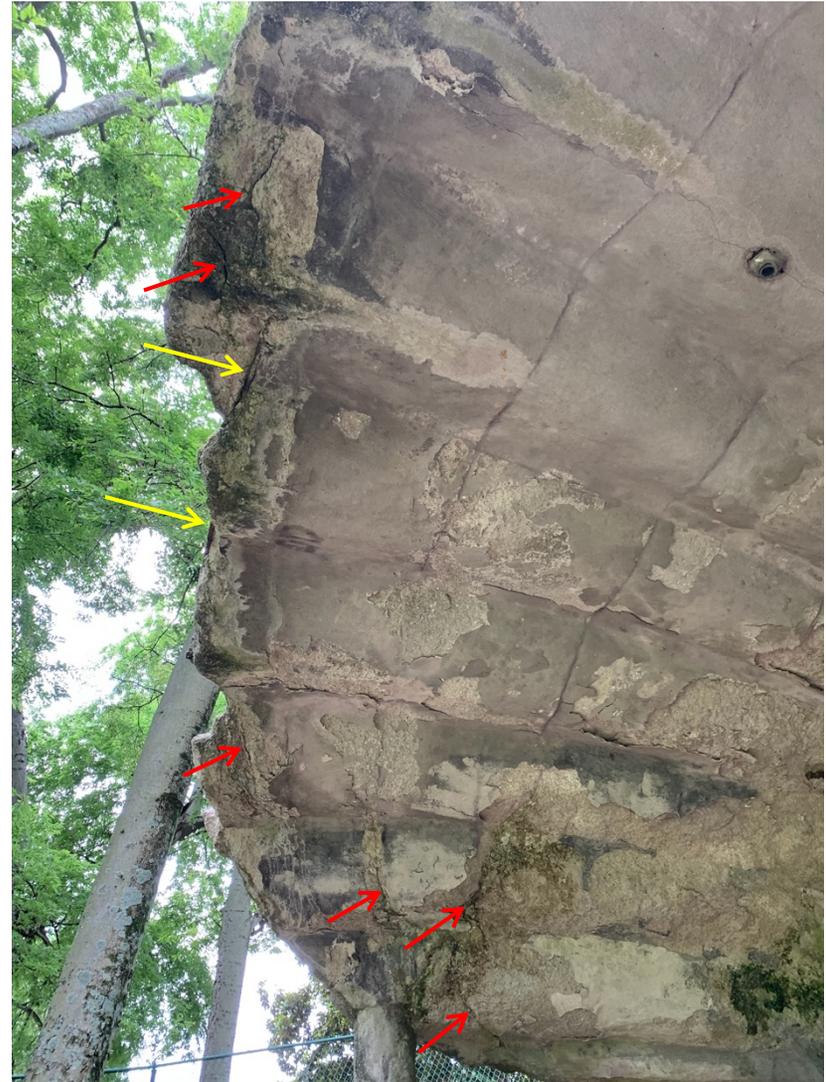
Figure 76: Underside of clamshell at west end; the same steel reinforcement in the preceding image can be seen here at the yellow arrow; numerous cracks are extant throughout approximately the first 12" of the clamshell from the front edge; while there is far less biogrowth on the top surface of the clamshell there are thick, possibly elastomeric, coatings concealing a significant portion of the underside of the shell that need to be removed so the underlying concrete can be assessed and repairs determined in conjunction with additional testing recommended above.

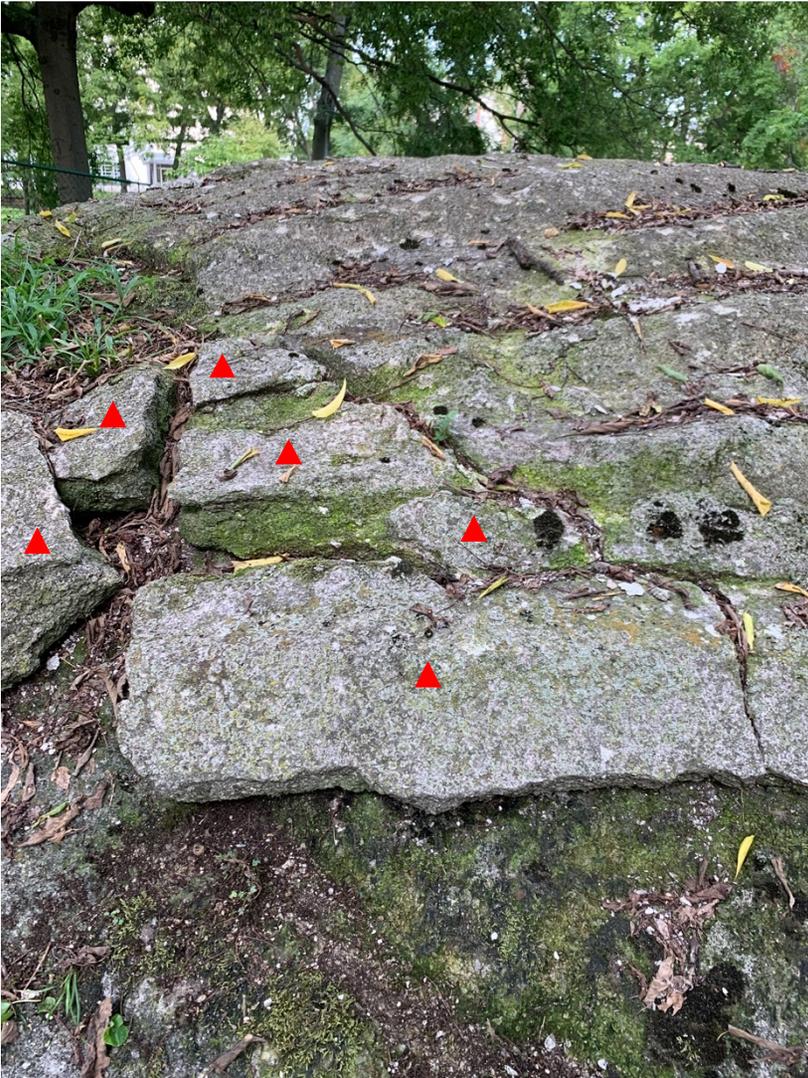
Figure 77: Top west of clamshell – triangles indicate cracked fragments that may be loose and large enough to remove, clean, stabilize and reattach; additional testing may determine they should be recast to better preserve the whole.

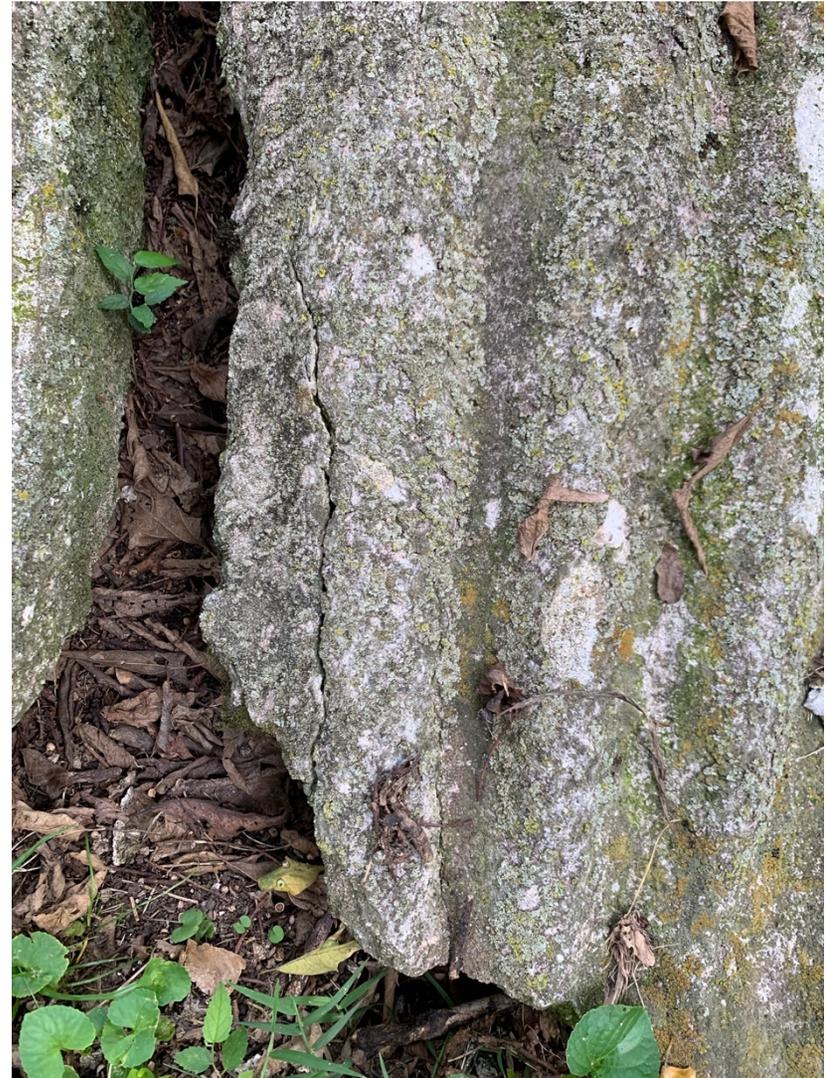
Figure 78: Back bottom of clamshell depicting cracked fragments that may be too small or disaggregated to preserve or additional testing will determine it is more beneficial to fill with a new casting or patch. The leaves seen at the left are collected in the separation between what is believed to be a cold joint between two different concrete lifts. That debris needs to be removed for better assessment of the substrate.

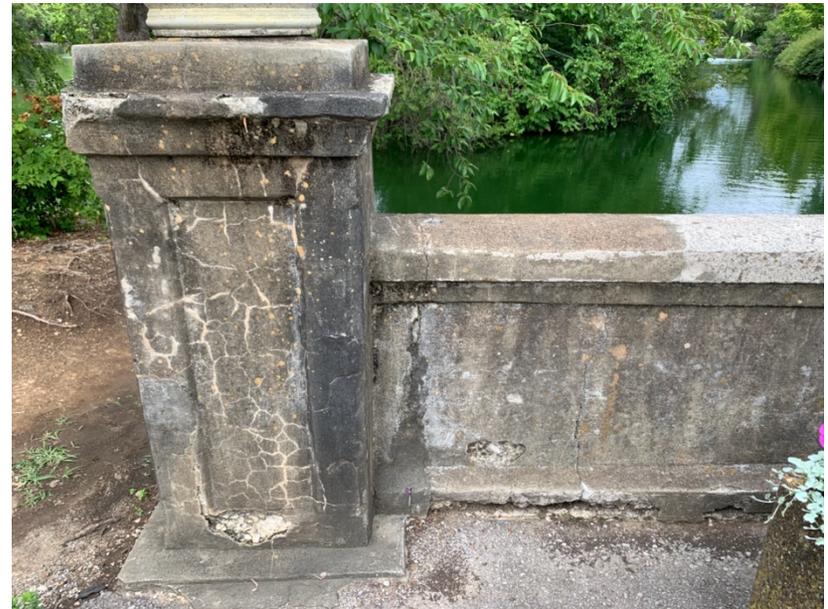
Figure 86: The northeast post, west face; note loss, cracking and salts in the parging.

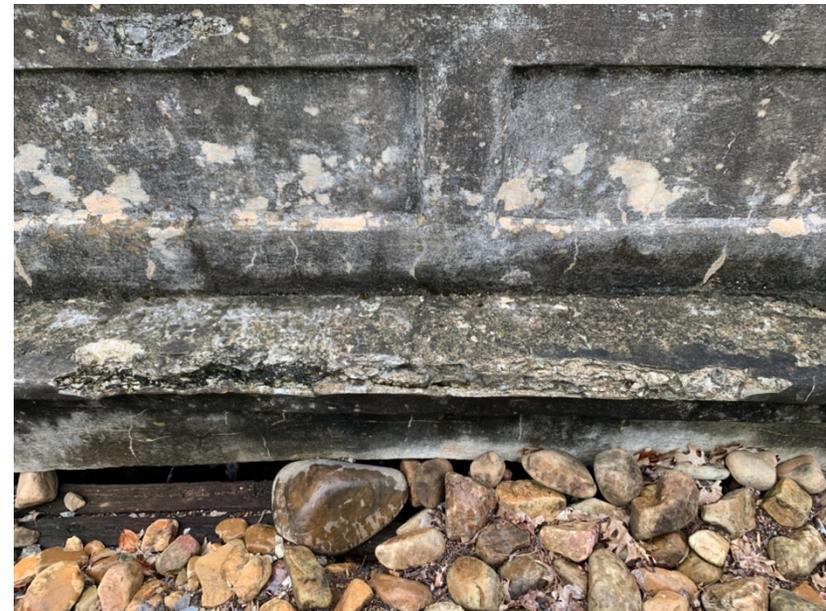
Figure 97: West side of west railing – the footing is the part of the railing in worst condition, detail shown here of loss, disaggregation, cracking, and biogrowth; this condition spans the length of the railing. Towards the bottom of the image the top of the arch is just visible.

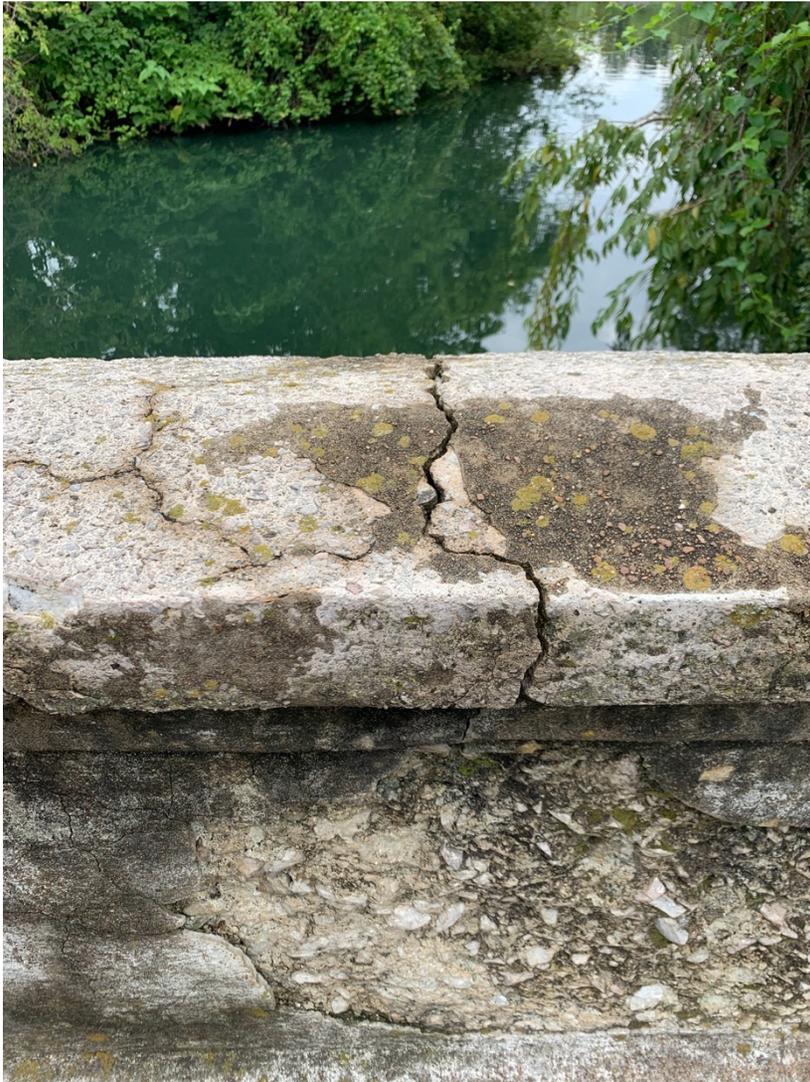
Figure 98: There are several large cracks on the top of the east railing; the cracks allow water ingress which at the Concrete Bridge means it gets behind the parging coat, accelerates the decay of the structural concrete, and eventually causes loss of parging, exposing the eroded decayed concrete; similar to the following image this results in a significant amount of surface loss over the years.

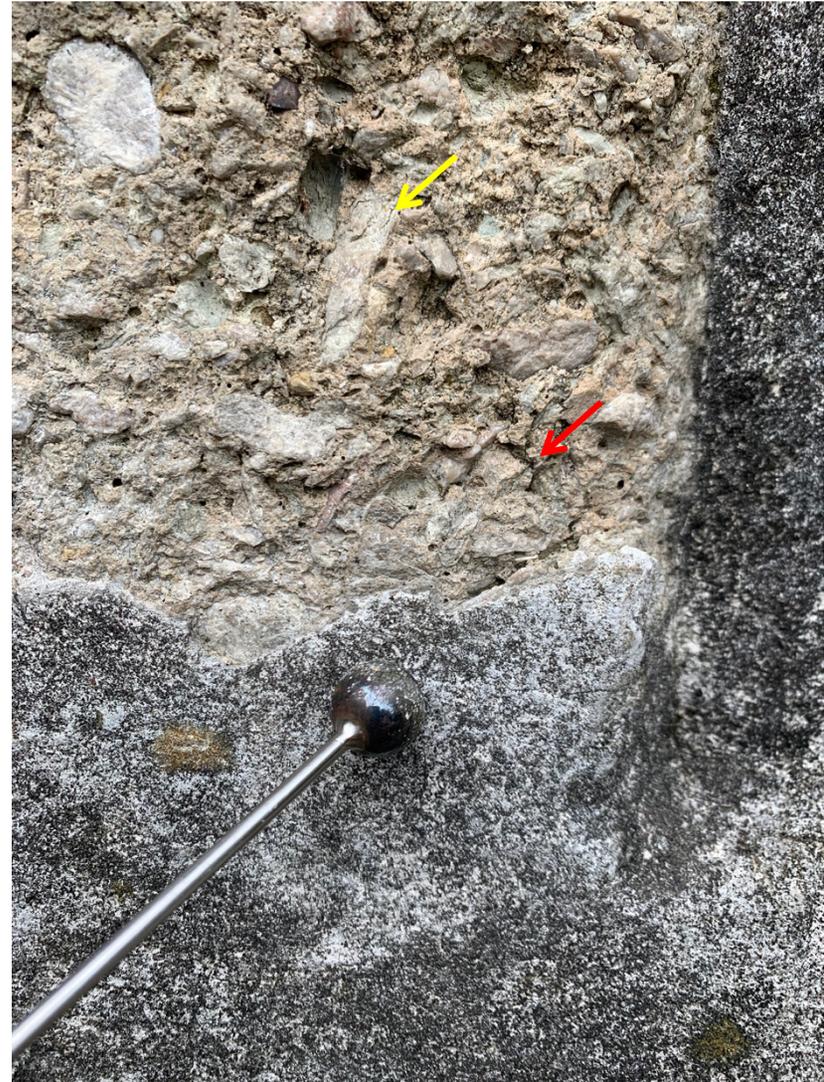
Figure 99: Detail at loss of parging – sounding tool is used to tap on parging and detect delamination which was almost 100% of the east railing's parging; note cracks in the concrete substrate that are in the cement matrix (red arrow) as well as through aggregate (yellow arrow). The aggregated surface typical of the exposed areas of concrete is not the original appearance which would have been much smoother due to pouring the concrete against formwork – this condition suggests a significant amount of surface loss over the last 110 years.

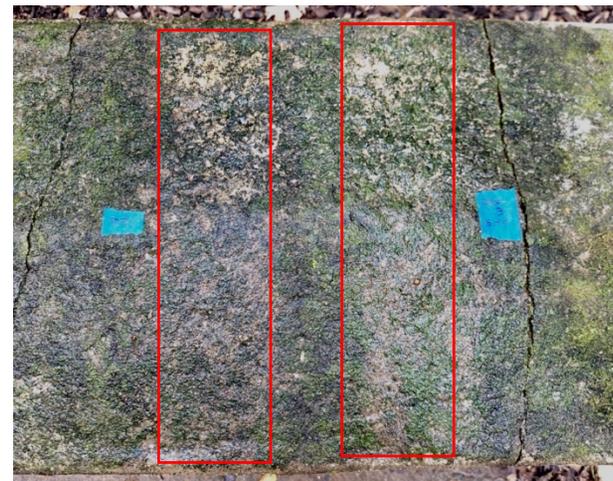
Figure 113: After cleaning tests across top of west railing. The results were not satisfactory though these cleaners can improve after a couple weeks of exposure. More testing should be done.

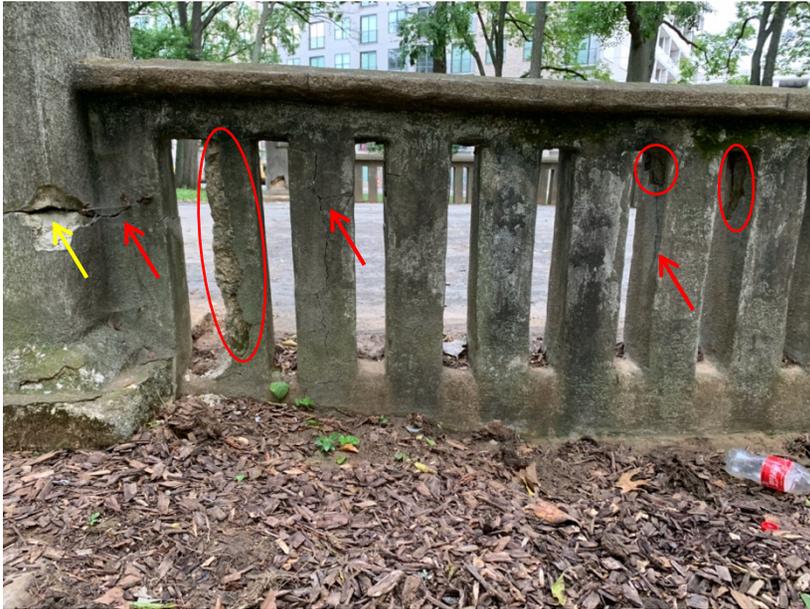
Figure 114: West side of west railing. Note cracks in parging at red arrows, cracks in structural concrete at yellow arrow, loss of parging in outlines.

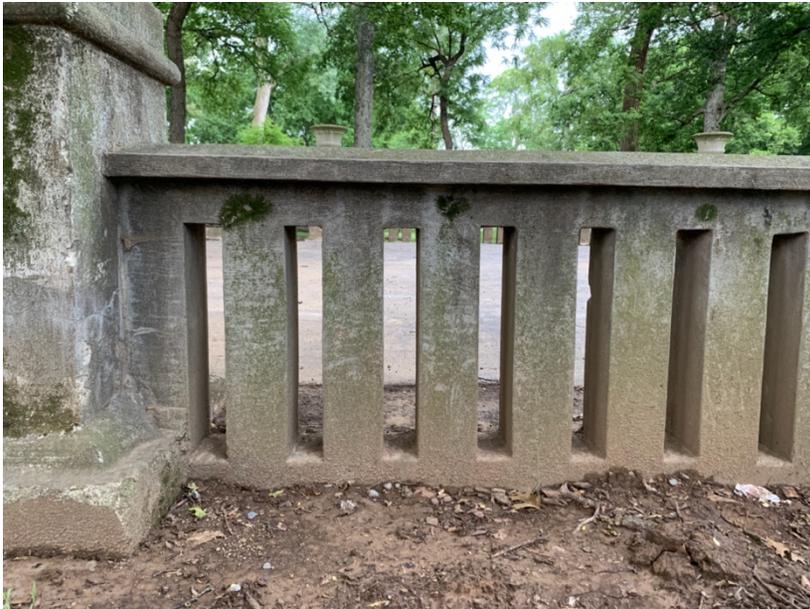
Figure 115: East face of east railing. Note the better condition of this railing which is true for the whole railing compared to the west railing. The parge coating may also be a later campaign than the west.
